# Home Inspection Report

## 1234 Any Street, City, State

**Prepared By:**  
CRITERION HOME INSPECTORS LLC  
P.O. BOX 513  
SUSSEX, WI. 53089

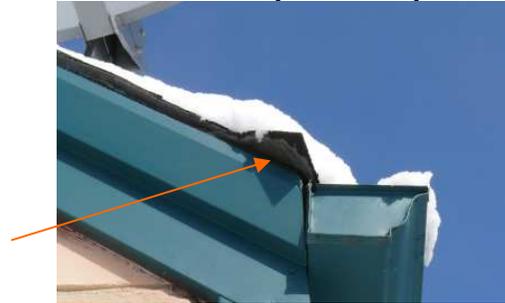
- **Deferred Cost:** Roof fifteen years old and older is a maintenance issue to consider down the road.
- **Monitor:** Older roofs are, by their nature, a high maintenance roof. Annual inspection and repair should be anticipated. In addition, the older flashings should be monitored. In some cases, a deteriorated flashing can result in expensive repairs, because sections of the roofing have to be removed. As a rule of thumb, replacement of the entire roof covering may be logical if more than ten percent of the roof requires repair.
- **Improve:** Roof on the garage is older than the homes roof. Replacement is likely, sooner than later.
- **Repair:** Loose or torn roofing shingle was observed at the southeast corner of the home.

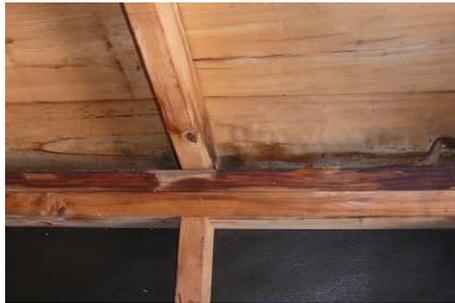
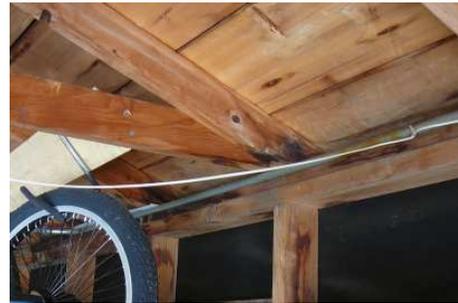
- **Monitor:** Water staining was observed under the eave within the garage.

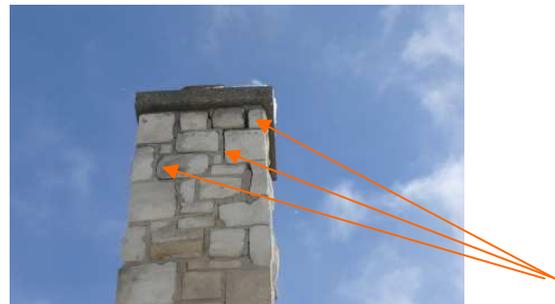
- **Repair:** The masonry chimney needs re-pointing (replacing the mortar between the bricks) to avoid water damage.

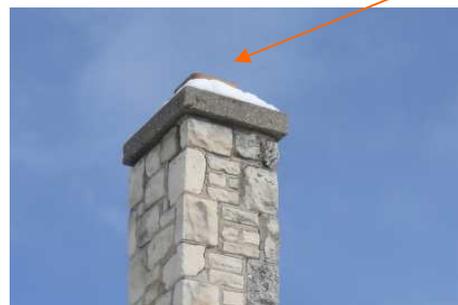
- **Repair, Safety Issue:** A vermin screen & rain cap should be installed on the chimney to avoid possible flue blockage.

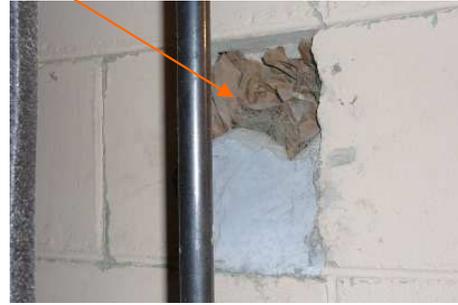
- **Repair:** Chimney hole in the basement should be repaired.

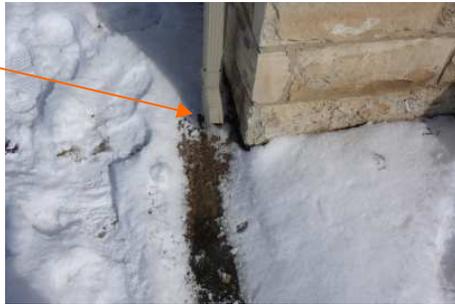
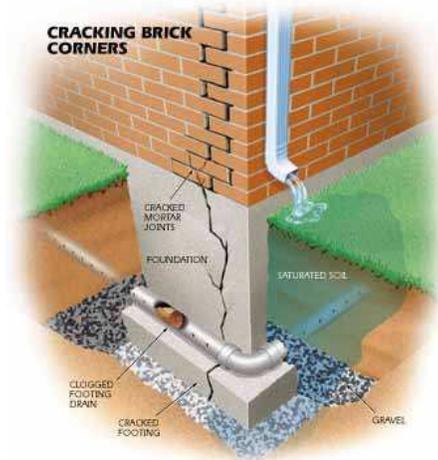
- **Repair:** The gutters require cleaning to avoid spilling roof runoff around the building – a potential source of water entry or water damage.
- **Repair:** The downspout(s) should discharge water at least five (5) feet from the house. Storm water should be encouraged to flow away from the building at the point of discharge.

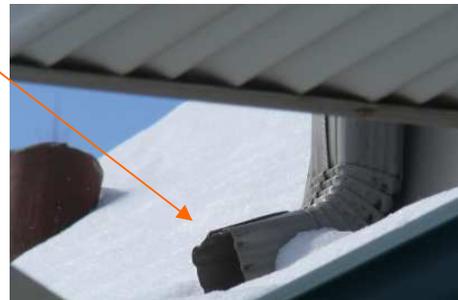
- **Repair:** Downspout(s) that discharge onto the roof should be extended to discharge directly into the gutters below. This condition, if left unattended, can result in premature deterioration of the roofing under the end of the downspout.

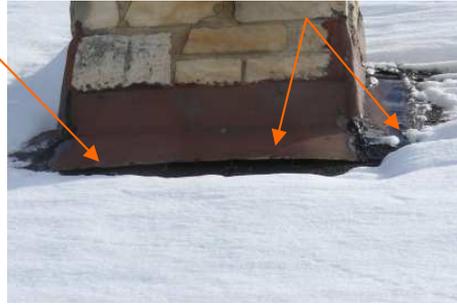
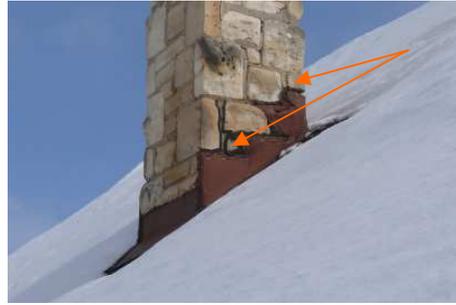
- **Repair:** The Chimney flashing leaks and should be replaced.

- **Repair:** The Chimney flashing is loose and should be re-secured to avoid leaks.

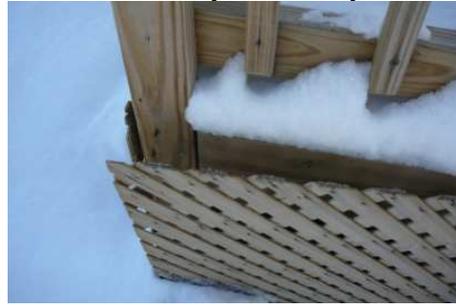
- **Improve:** Lattice work is loose on the front deck.

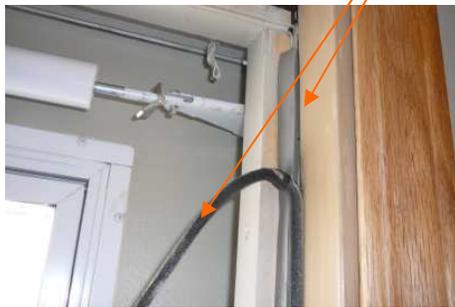
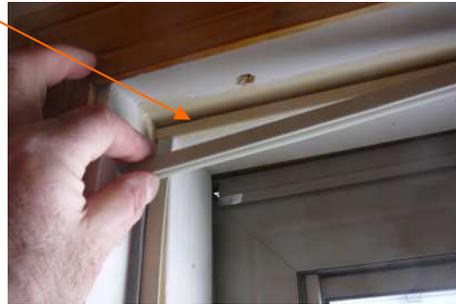
- **Improve:** Weather Stripping repairs needed in front and side entries.

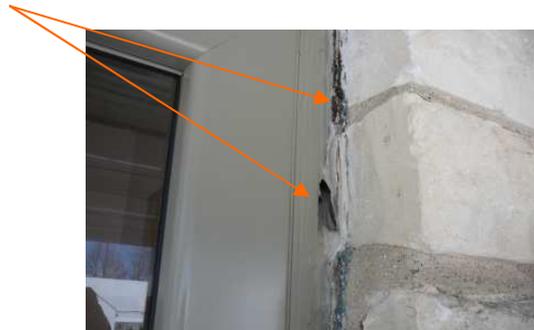
- **Repair:** The front door requires caulking.

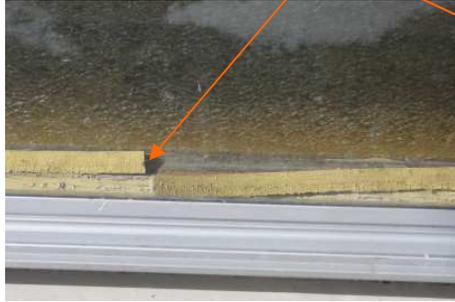
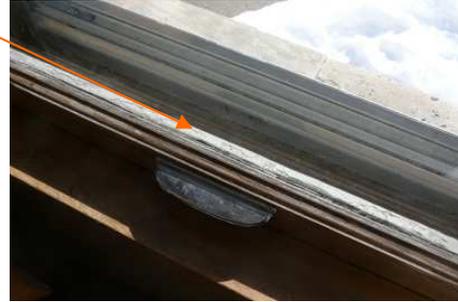
- **Repair:** Some windows are in need of glazing (putty) improvements.

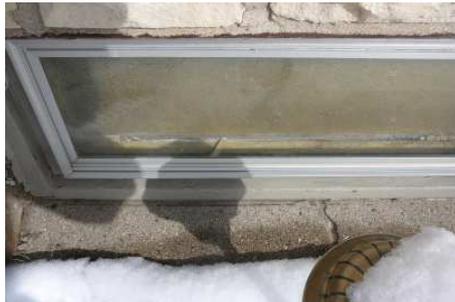
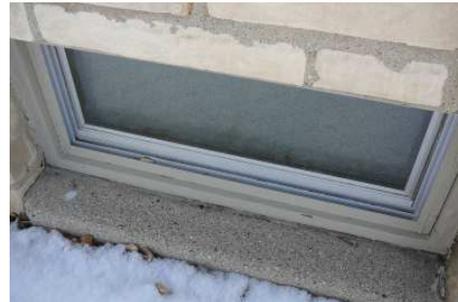
- **Repair:** As is very typical, the basement windows have been neglected. They should be repaired or replaced as desired. Wood/soil contact should be avoided to reduce insect and rot-damage risk.

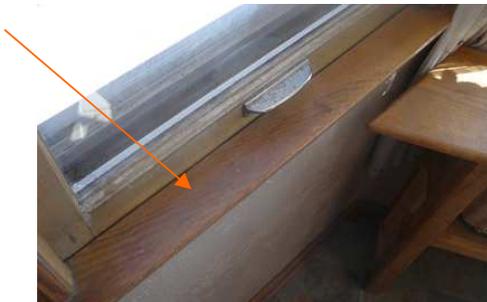
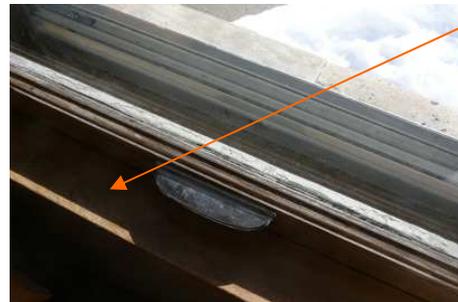
- **Repair:** Localized evidence of water staining was visible at window sills. Repairs should be undertaken in when painting/staining.

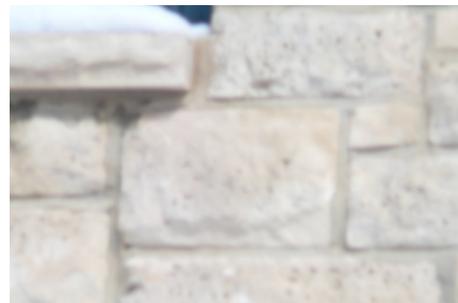
- **Monitor:** Common minor cracks were observed on the exterior walls of the house. This implies that structural movement has occurred. The location, size, shape of these cracks is common. The inspection did not find evidence of significant movement requiring immediate major repairs.

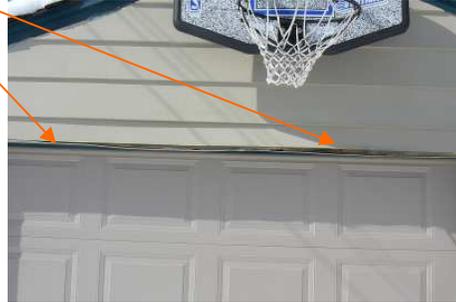
- **Repair:** The Trim of the overhead garage door is incomplete and needs repair.

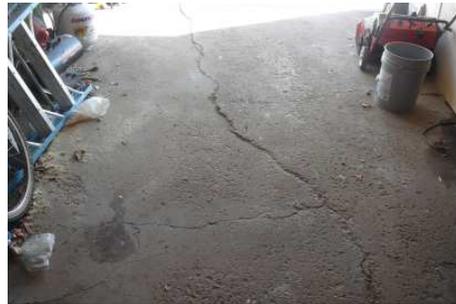
- **Monitor, Safety Issue:** Pronounced floor cracks were noted in the garage. While this amount of cracking is unusual, this slab is not a structural component you should be aware of the trip hazard.

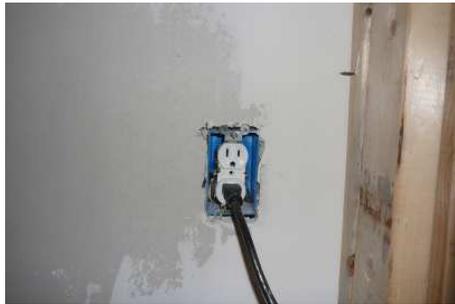
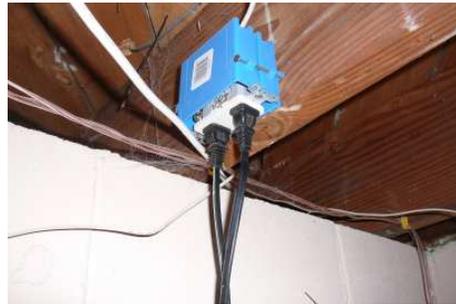
- **Repair:** Ungrounded 3-prong outlets should be repaired in Master Bedroom south wall. In some cases a ground wire may be present in the electrical box and simply needs to be connected. If no ground is present “repair” can be as simple as filling the ground slot with epoxy. Better, since having a ground increases safety, a grounded circuit could be strung to this outlet, or a separate ground wire could be connected. Some electrical codes allow the installation of a ground fault circuit interrupter (GFCI) type outlet where grounding is not provided. In this case the GFCI may work but can’t be tested by normal means.
- **Repair:** Missing outlet cover plates & knockouts should be replaced to avoid a shock hazard.

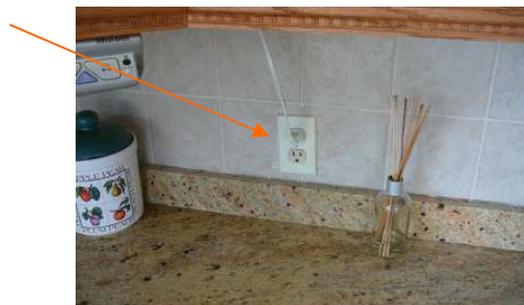
- **Repair:** The installation of a ground fault circuit interrupters (GFCI) is recommended. The installation of ground fault circuit interrupter (GFCI) devices is advisable on the exterior of the home, garage, bathrooms, whirlpools, swimming pool equipment and some kitchen outlets and or any outlets within 6’ of water (**Kitchen**). On circuits with multiple outlets; the lead outlet would suffice, as it will then give protection to all outlets on that given circuit. A GFCI offers increased protection from shock or electrocution.

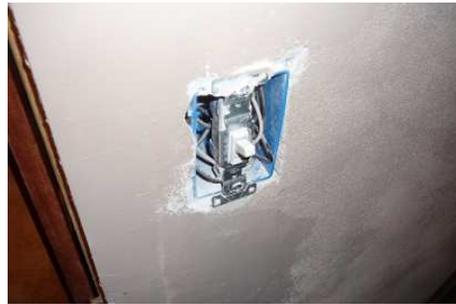
- **Repair:** The missing light switch cover plates. under the basement stairs.

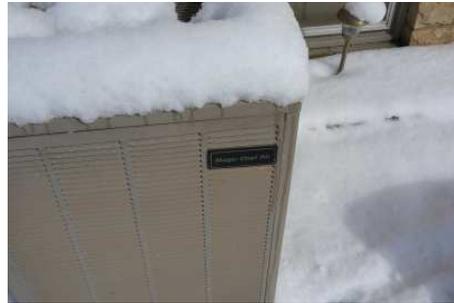
As the system is old, it will require repairs or replacement soon.

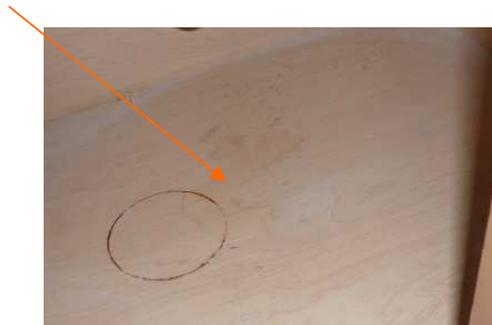
- **Deferred Cost:** Water Heater: 5 + years old and older is a maintenance issue to consider down the road.
- **Repair:** Water leak was observed under the double sink in the upper bath cabinet right side.

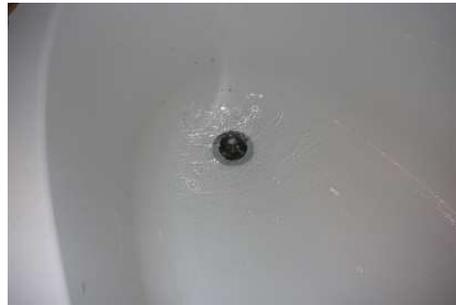
- **Monitor:** The bathtub was observed to drain slowly, suggesting that an obstruction may exist.

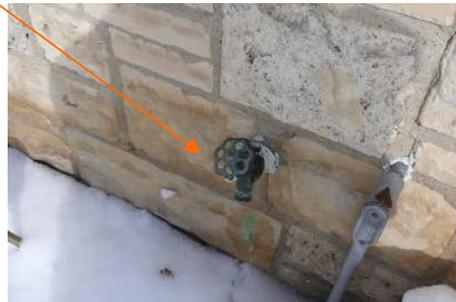
- **Repair:** It is recommended that an anti-siphon device be added to the hose bib(s).
- **Improve:** Frost free hose bibs are recommended for the outside. Water was still on at the rear of the home. Shut off was found under a ceiling panel in the basement office area.

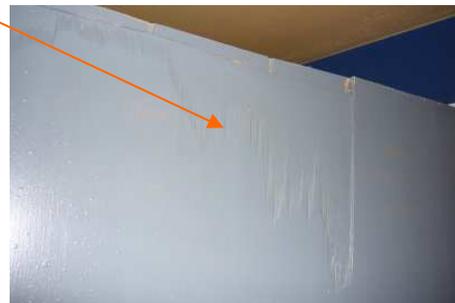
- **Improve:** Weather stripping (Exterior Front Door) are in need of improvements.
- **Improve:** Master Bedroom door damaged.

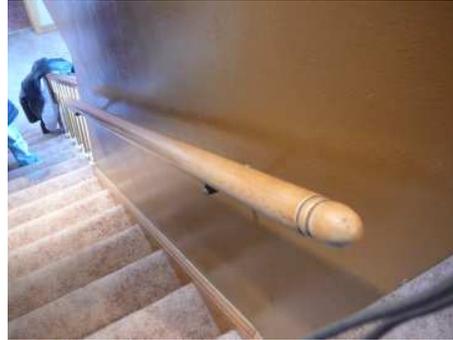
- **Monitor:** The railing for the stairway is loose.

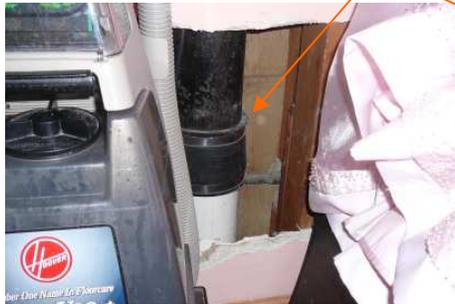
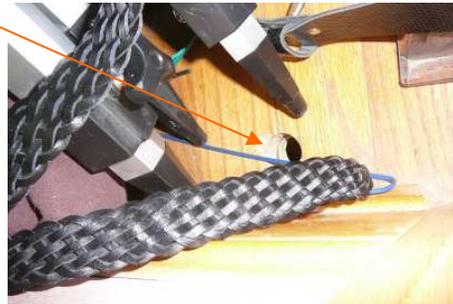
- **Monitor:** Minor cracks & holes were noted.
- **Monitor:** Evidence of patching was detected.

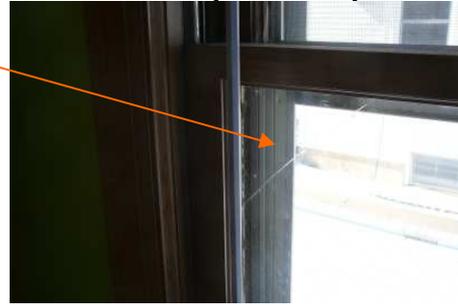
- **Monitor:** Water staining was observed below the window sill(s). Caulking should be improved as a first step. Refer also to the Exterior section of this report.
- **Monitor:** The window(s) are cracked in the northwest bedroom. Improvement is not a high priority.

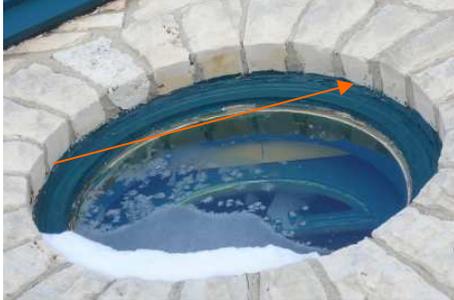
Calking needed

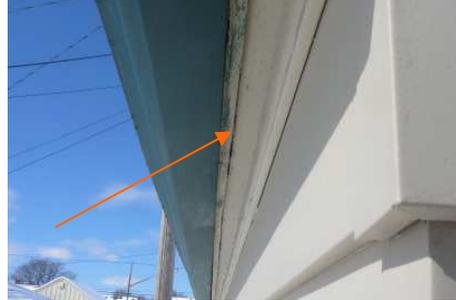
Painting needed

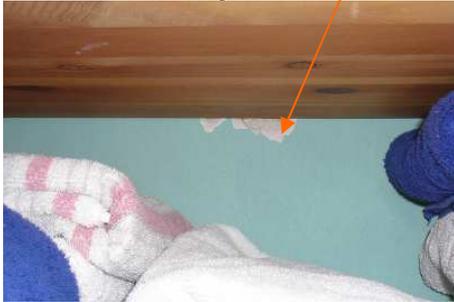
Wall damage in closet

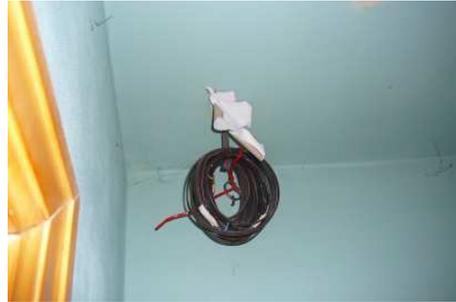
Antenna wires in front hall closet

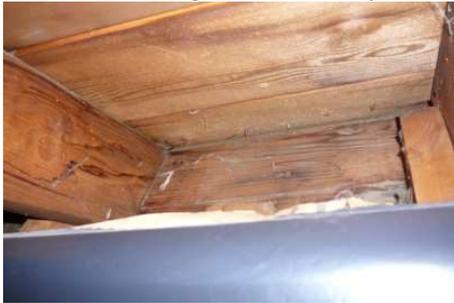
Water staining around chimney in attic

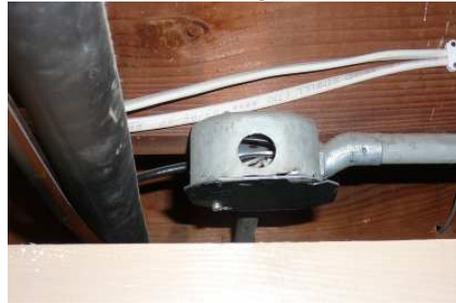
Knockout missing in basement

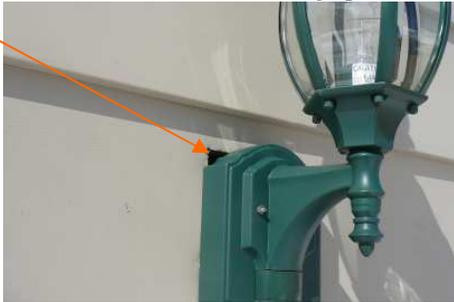
Over cut trim water damage potential

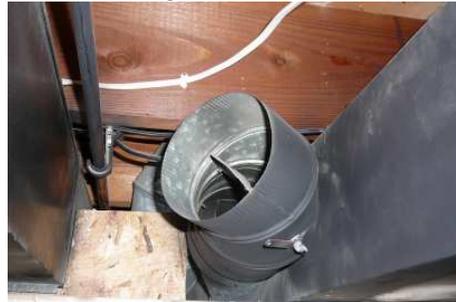
Missing heat duct cover
